Montgomery County Fire and Rescue Service

Post Incident Analysis – #5 Burkett Court

Incident #10-0134583

December 02, 2010

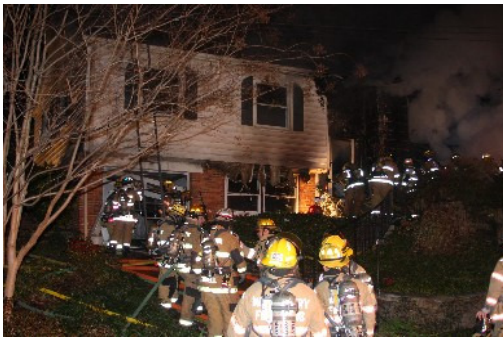
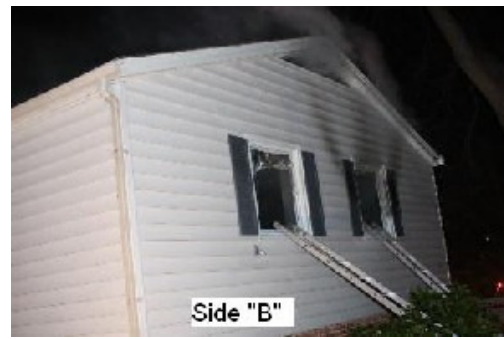
Truck personnel threw ladders to the windows on Side "B" as well as several ladders on Side "C" that accessed the roof (no operations were conducted on the roof). Only one ladder was thrown on Side "A" (quadrant alpha) and that ladder went to the roof, not to the bedroom window. The ladder selected was too long to be of use in that window.

The Rapid Intervention Group (RIG) was formed on Side "A" and assisted in identifying hazardous conditions including a badly damaged PEPCO house service.
